# espc::home report

Flat 4  
152 McDonald Road  
EDINBURGH  
EH7 4NL  
09/11/2023

# Single Survey

<b>Property address</b>	2f2, 152 McDonald Road, Broughton, EDINBURGH, EH7 4NL
-------------------------	---

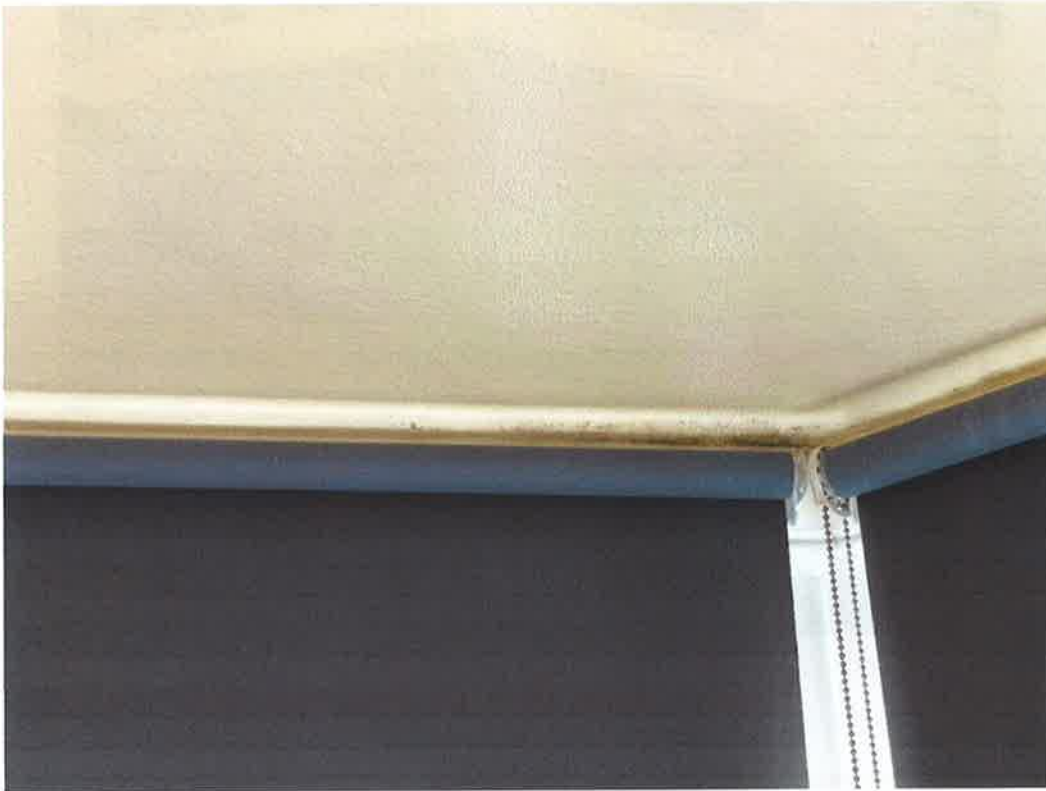
The photo above shows the water ingress to the smaller west facing bay window. The photos below show some of the causes; the felt is coming away from the coping stones and there joints are coming apart as the key demonstrates. **The owners have decided to leave this roof for now.**

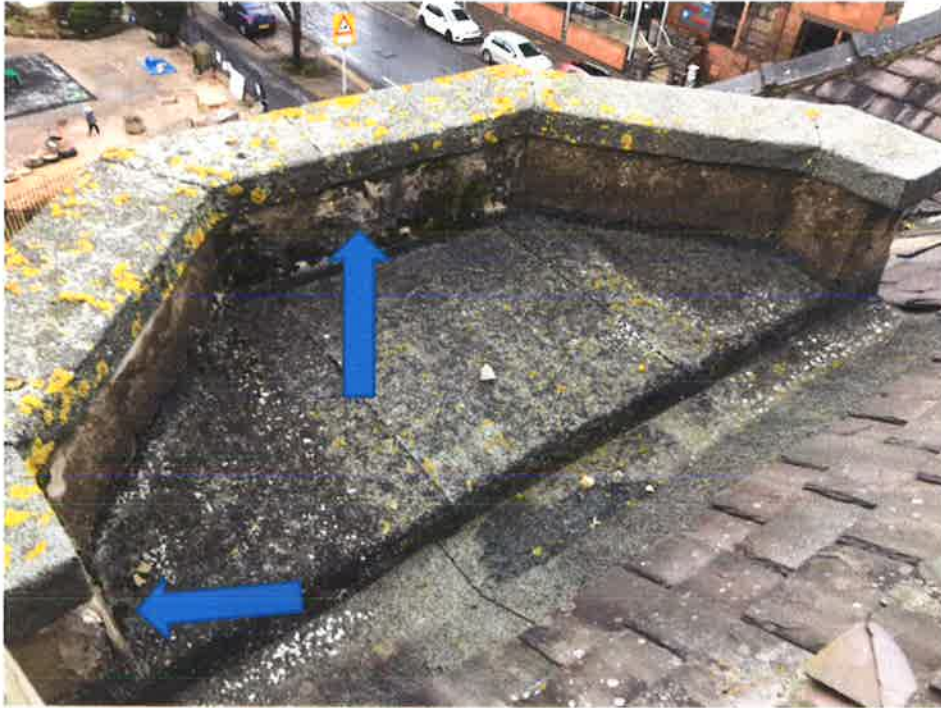
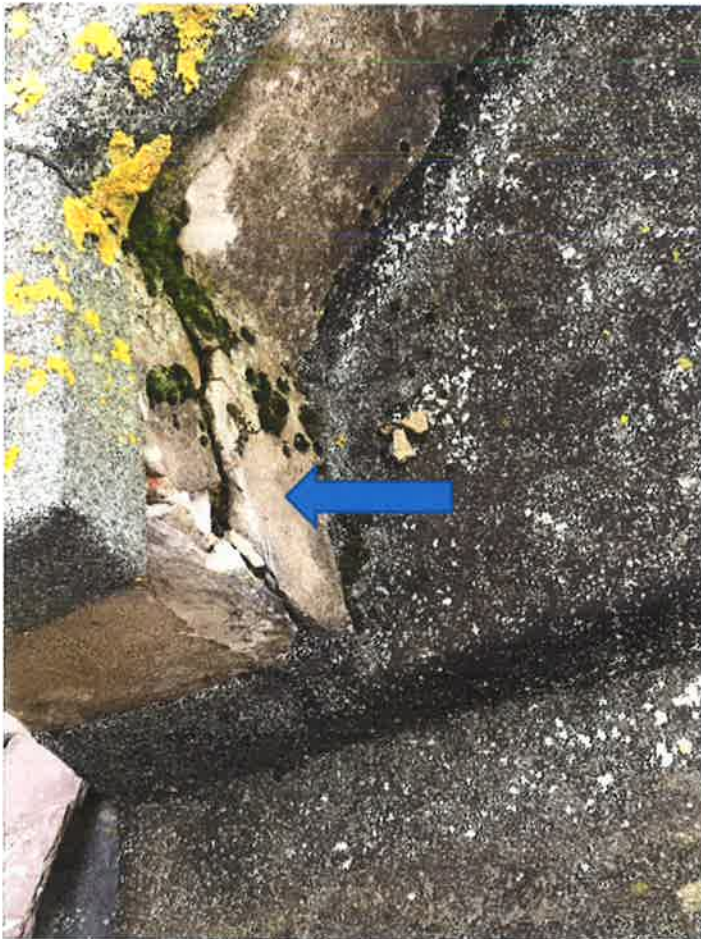
Further photos of the west facing bay. The render on the wallhead is cracked and will be letting in water.

Rather than re-render, we will mechanically fix timber to the upstand and coping stones and run the new felt up and onto the copes to fully seal the area.

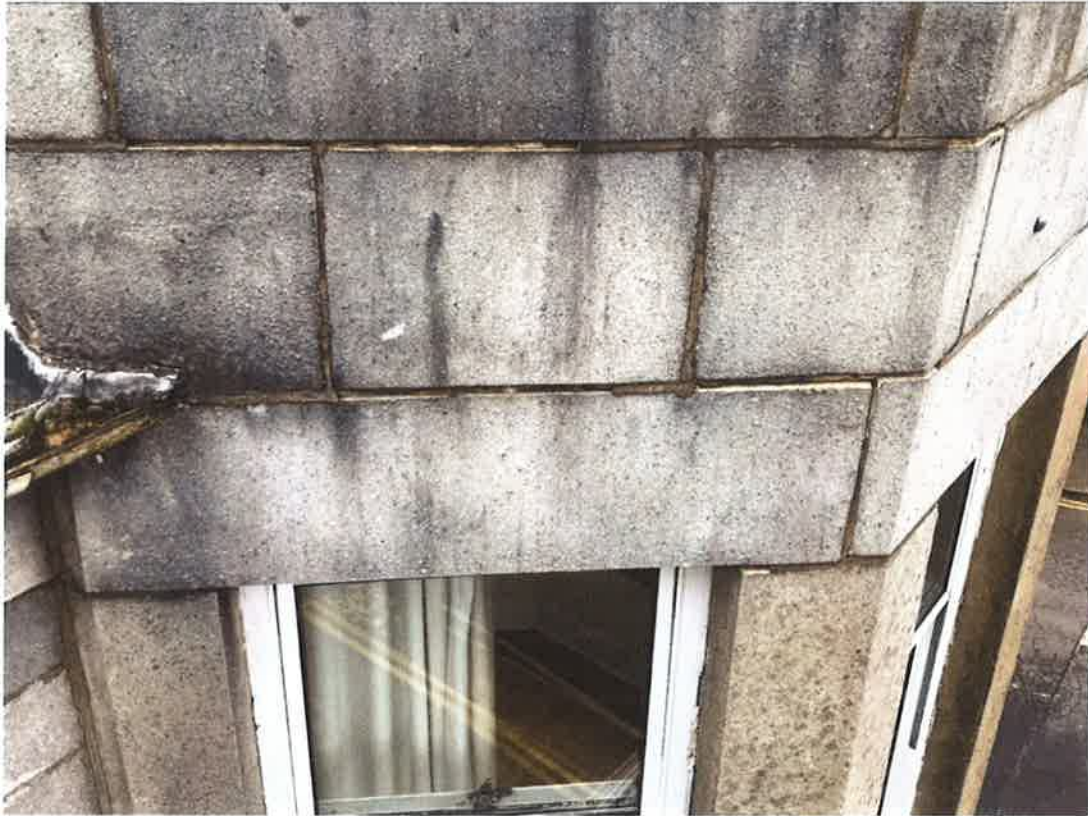
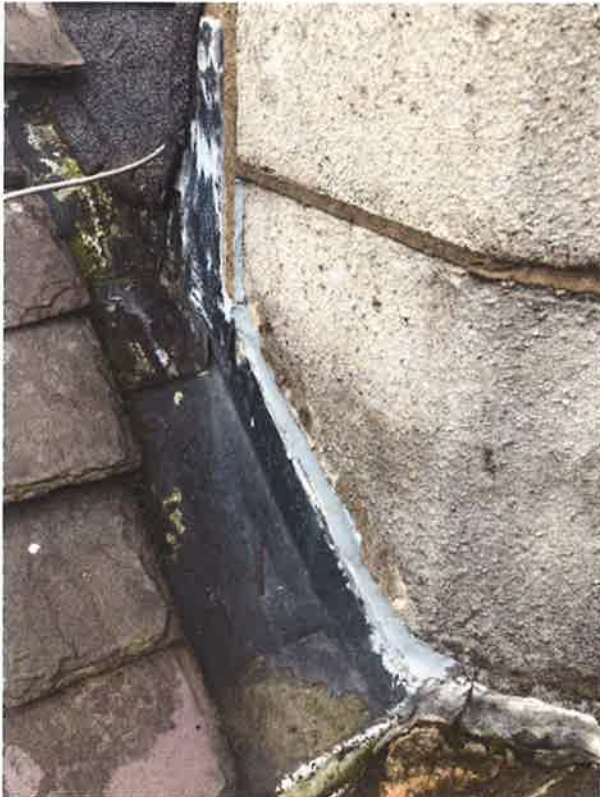
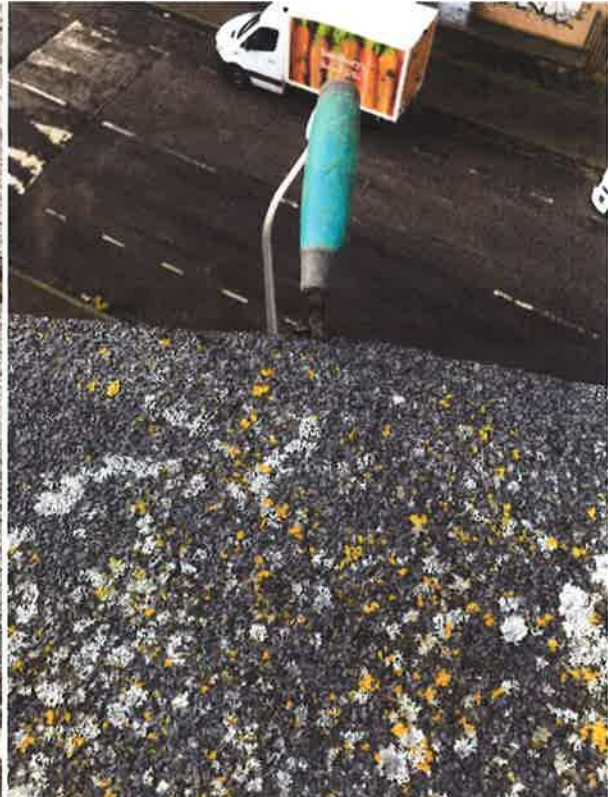
The top photo shows some of the failed pointing. The bottom left shows the left hand watergate which will need to be renewed with the flat roof. The other photo shows the felt coming away from the cope. This commonly happens when felt is heat sealed onto stone. We will mechanically fit timber to the copes and upstands and seal the felt to this.

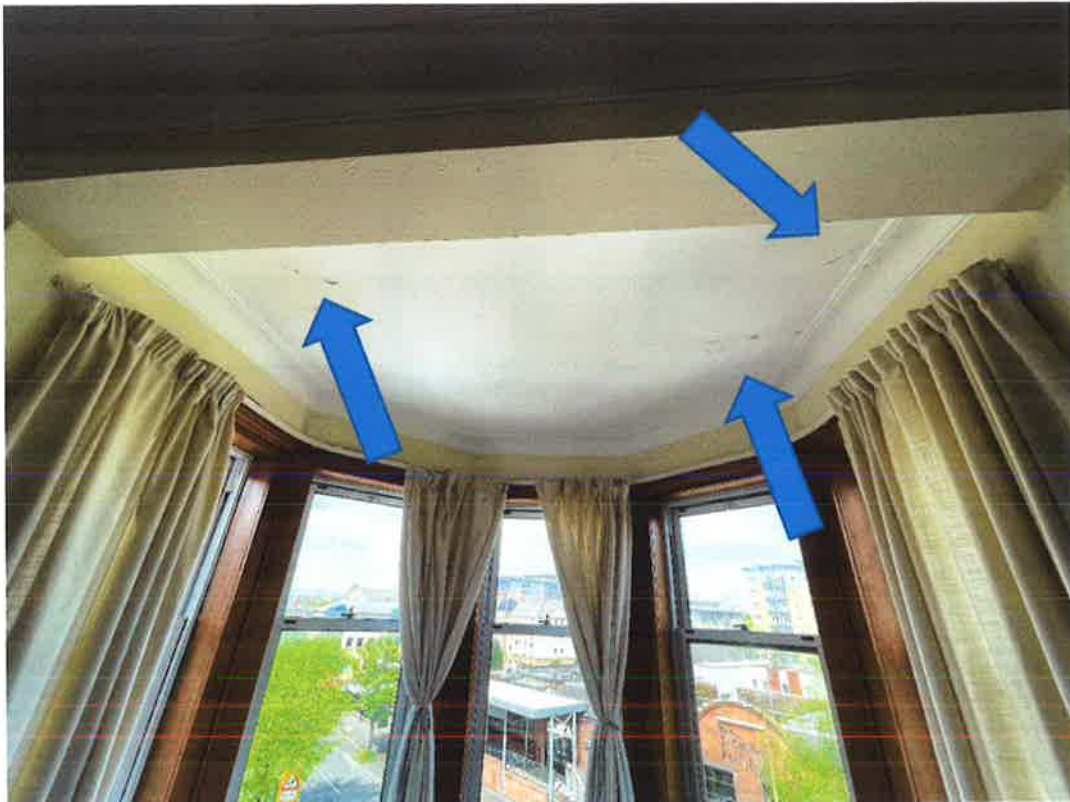
The larger north facing bay window is in a similar condition to the west facing one. Joints have failed, vegetation is growing out from between the felt and coping stones. This roof will also need to be stripped and renewed.

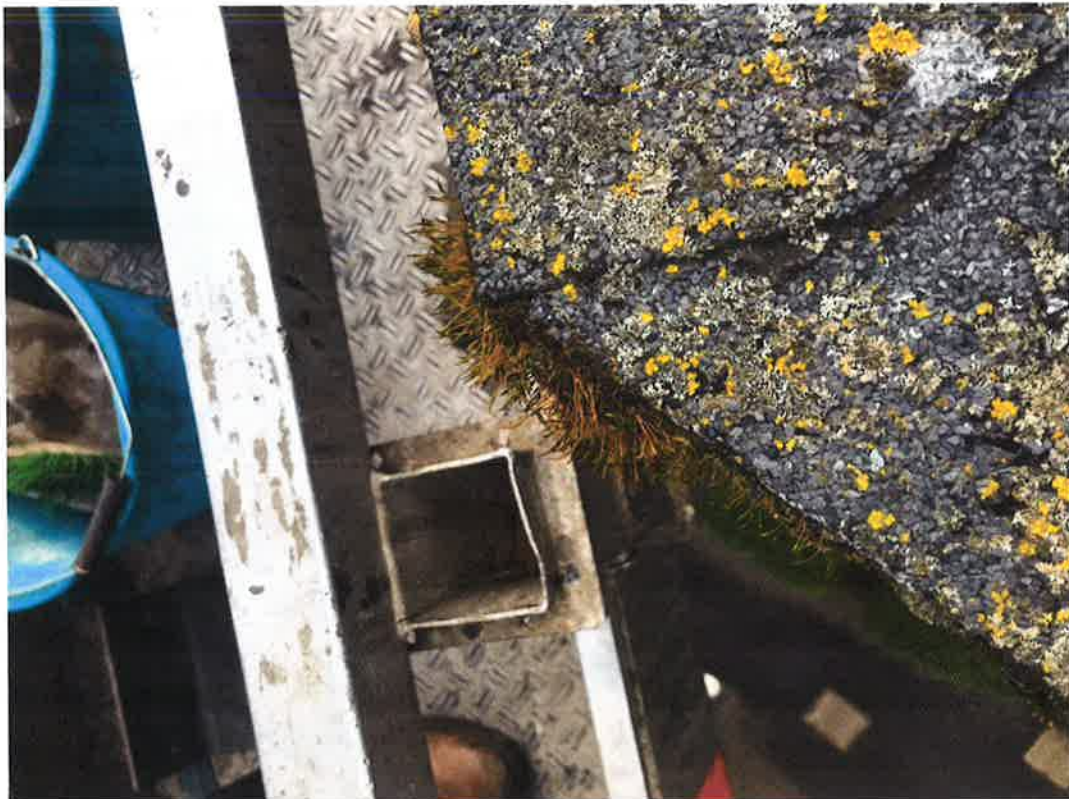
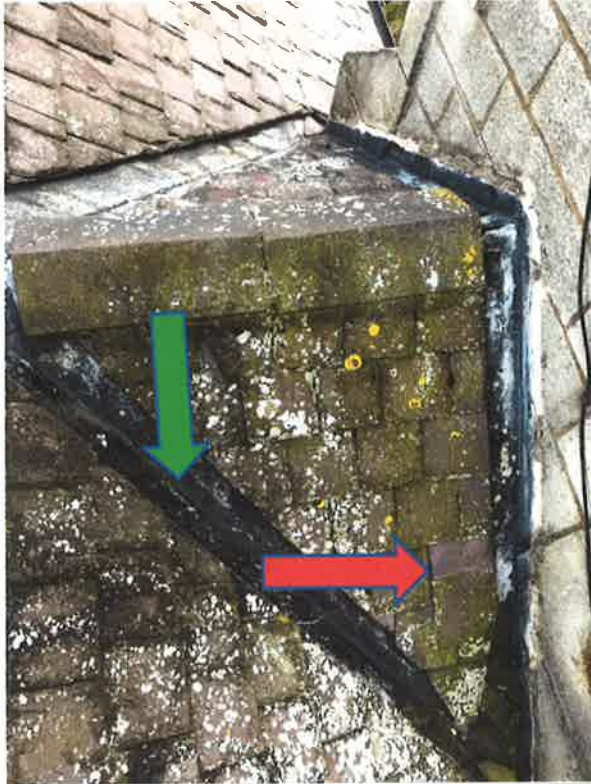
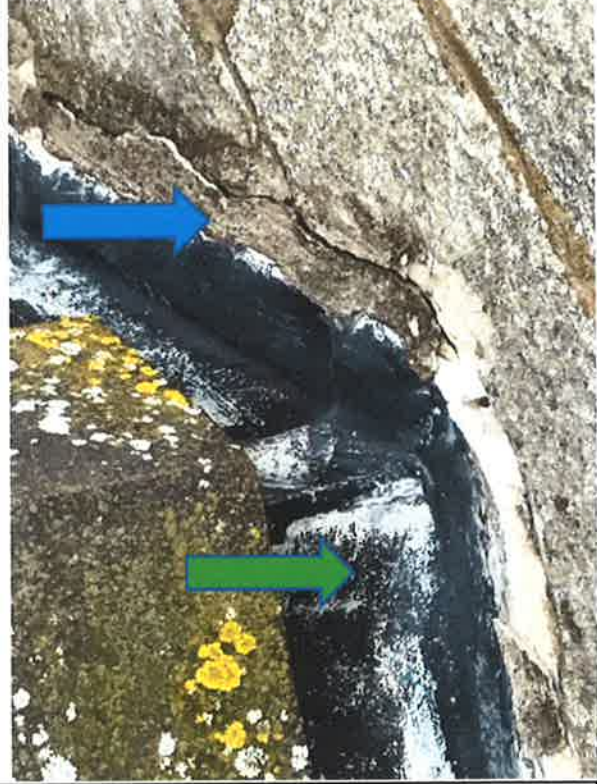
These photos show the very poor condition of the chimney saddle. The slates are thin Welsh slates and prone to cracking and breaking and slipping out (red arrows). The raggle to the watergate is cracked (blue arrow) and the zinc valley gutters are thin and letting in water (green arrows)

We carried out some repairs to these areas from the cherry picker but they are only temporary. We recommend the valleys, watergates and slating in the area are renewed.
