espc::home report

Meldrums Mill
DUNFERMLINE
KY12 0RZ
15/06/2023

Single Survey

Property address	Meldrumsmill, Bowershall, DUNFERMLINE, KY12 0RZ
-------------------------	--

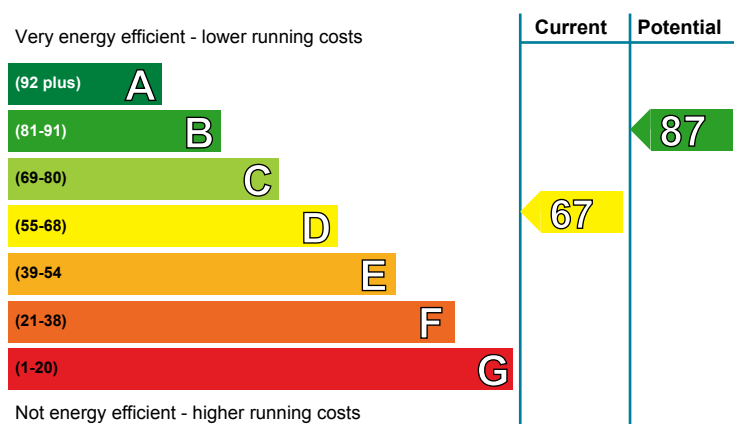
Energy Efficiency Rating

This graph shows the current efficiency of your home, taking into account both energy efficiency and fuel costs. The higher this rating, the lower your fuel bills are likely to be.

Your current rating is **band D (67)**. The average rating for EPCs in Scotland is **band D (61)**.

The potential rating shows the effect of undertaking all of the improvement measures listed within your recommendations report.

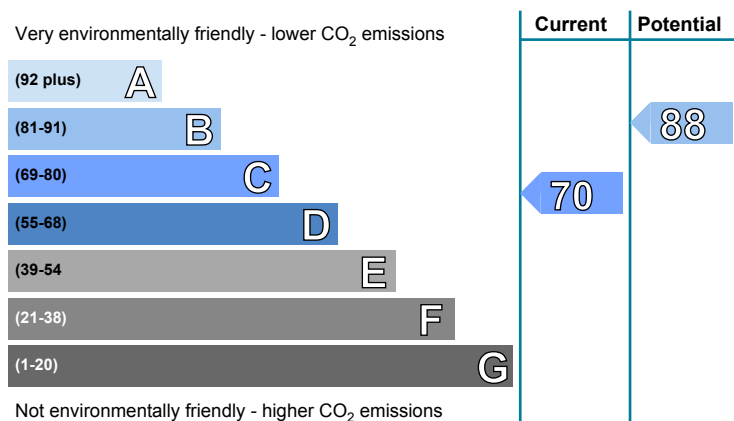
Environmental Impact (CO₂) Rating

This graph shows the effect of your home on the environment in terms of carbon dioxide (CO₂) emissions. The higher the rating, the less impact it has on the environment.
