## Home Report

147 Parkhead Avenue Edinburgh EH11 4RW

# single survey

## survey report on:

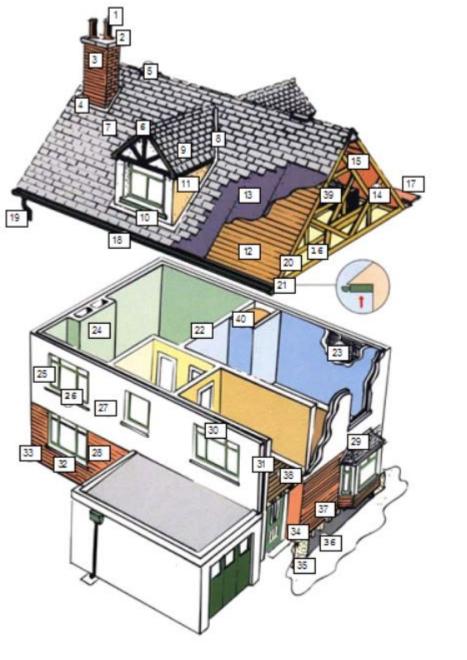
## Sectional Diagram showing elements of a typical house

Reference may be made in this report to some or all of the above component parts of the property. This diagram may assist you in locating and understanding these items.
