# espc::home report

7/6 Iona Street  
Edinburgh  
EH6 8SG  
20/02/2024

# Single Survey

<b>Property address</b>	2f2, 7 Iona Street, Leith, Edinburgh, EH6 8SG
-------------------------	---

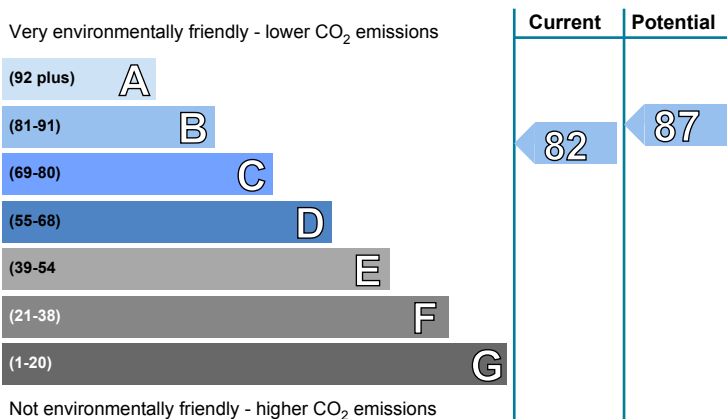
## Environmental Impact (CO<sub>2</sub>) Rating

This graph shows the effect of your home on the environment in terms of carbon dioxide (CO<sub>2</sub>) emissions. The higher the rating, the less impact it has on the environment.
