93/1 Morrison Street EDINBURGH EH3 8BX 26/02/2024

survey report on:

93 Morrison Street, West End, EDINBURGH, EH3 8BX Customer Mr K Thomson Customer address Prepared by DM Hall LLP	7 1	
Customer address Prepared by DM Hall LLP	Property address	93 Morrison Street, West End.
Customer address Prepared by DM Hall LLP		
Prepared by DM Hall LLP	Customer	Mr K Thomson
Prepared by DM Hall LLP		
	Customer address	
Date of inspection 23rd February 2024	Prepared by	DM Hall LLP
Date of inspection 23rd February 2024		
	Date of inspection	23rd February 2024

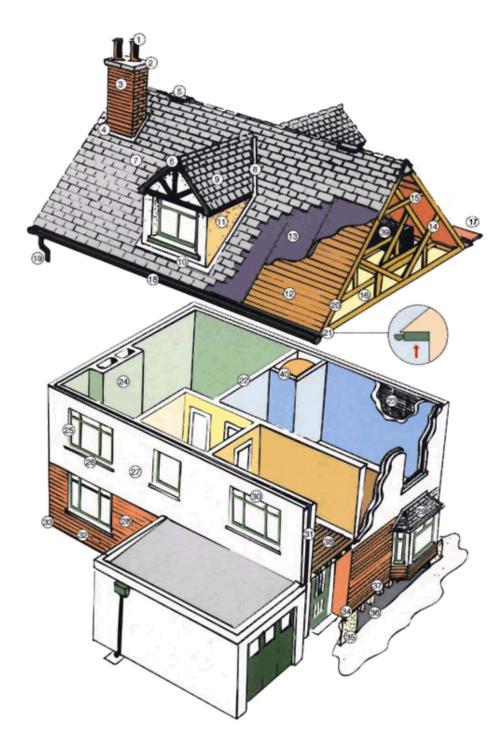
Sectional Diagram showing elements of a typical house

Reference may be made in this report to some or all of the above component parts of the property. This diagram may assist you in locating and understanding these items.

- 1) Chimney pots
- 2) Coping stone
- 3) Chimney head
- 4 Flashing
- 5) Ridge ventilation
- 6) Ridge board
- 7) Slates / tiles
- (8) Valley guttering
- 9 Dormer projection
- 10 Dormer flashing
- 11) Dormer cheeks
- 12) Sarking
- (13) Roof felt
- (14) Trusses
- (15) Collar
- 16) Insulation
- (17) Parapet gutter
- (18) Eaves guttering
- 19) Rainwater downpipe
- 20) Verge boards/skews
- Soffit boards
- 22) Partition wall
- 23) Lath / plaster
- 24) Chimney breast
- 25) Window pointing
- 6) Window sills
- 27) Rendering
- (28) Brickwork / pointing
- 29) Bay window projection
- 30 Lintels
- (31) Cavity walls / wall ties
- 32) Subfloor ventilator
- 33 Damp proof course
- 34) Base course
- 35) Foundations
- 36) Solum
- Floor joists
- 38) Floorboards
- 39) Water tank
- 40 Hot water tank
