espc::home report

4 Glencoe Path
PRESTONPANS
EH32 9FF
03/02/2021

Single Survey

Property address	4 Glencoe Path PRESTONPANS EH32 9FF
-------------------------	---

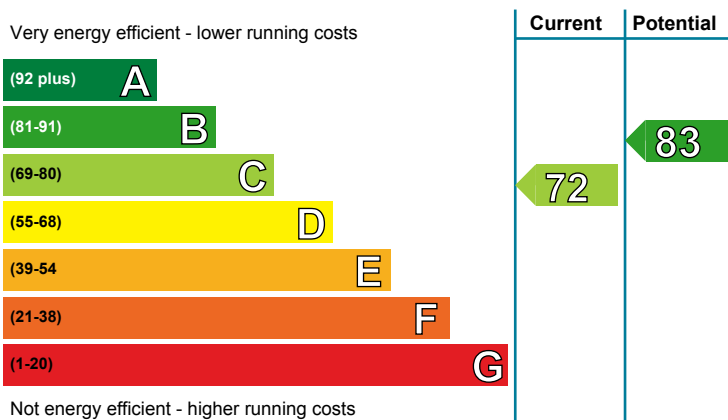
Energy Efficiency Rating

This graph shows the current efficiency of your home, taking into account both energy efficiency and fuel costs. The higher this rating, the lower your fuel bills are likely to be.

Your current rating is **band C (72)**. The average rating for EPCs in Scotland is **band D (61)**.

The potential rating shows the effect of undertaking all of the improvement measures listed within your recommendations report.
