espc:home report

Home Report Index

survey report on:

Property address	454 Old Dalkeith Road EDINBURGH EH16 4SS
-------------------------	--

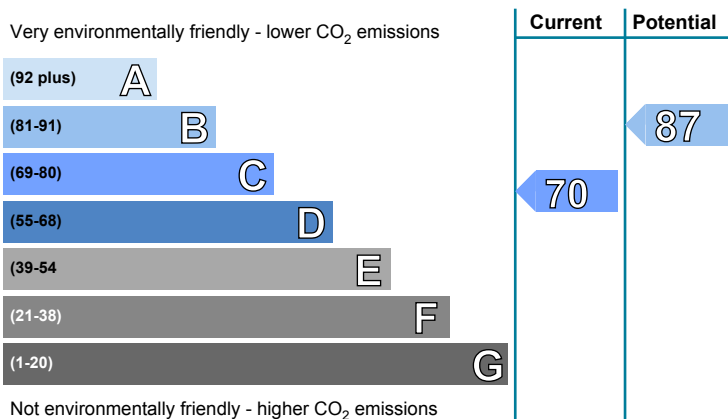
Environmental Impact (CO₂) Rating

This graph shows the effect of your home on the environment in terms of carbon dioxide (CO₂) emissions. The higher the rating, the less impact it has on the environment.
