espc::home report

39/12 Caledonian Crescent
EDINBURGH
EH11 2AQ
23/09/2021

survey report on:

Property address	Flat 12 39 Caledonian Crescent Dalry EDINBURGH EH11 2AQ
Customer	Mr C Anderson
Customer address	
Prepared by	DM Hall LLP
Date of inspection	21st September 2021

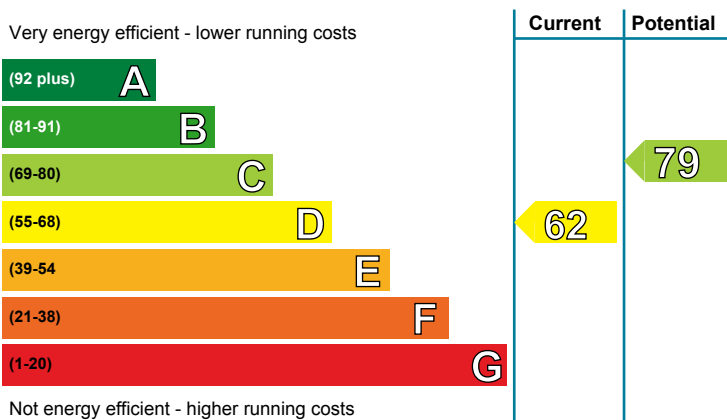
Energy Efficiency Rating

This graph shows the current efficiency of your home, taking into account both energy efficiency and fuel costs. The higher this rating, the lower your fuel bills are likely to be.

Your current rating is **band D (62)**. The average rating for EPCs in Scotland is **band D (61)**.

The potential rating shows the effect of undertaking all of the improvement measures listed within your recommendations report.
