espc:home report

43/5 (3F1) Falcon Avenue
Edinburgh
EH10 4AL
03/04/2025

Flat 43/5,
Falcon Avenue,
Edinburgh,
EH10 4AL

Single Survey

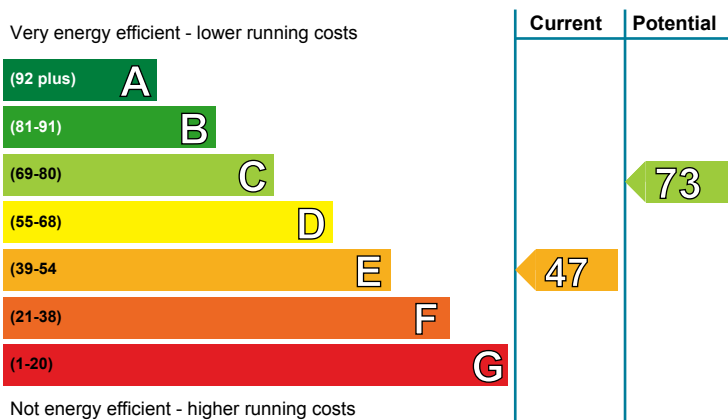
Energy Efficiency Rating

This graph shows the current efficiency of your home, taking into account both energy efficiency and fuel costs. The higher this rating, the lower your fuel bills are likely to be.

Your current rating is **band E (47)**. The average rating for EPCs in Scotland is **band D (61)**.

The potential rating shows the effect of undertaking all of the improvement measures listed within your recommendations report.
