29/3 (1F3) Hillside Street
Edinburgh
EH7 5HD
27/06/2025

1F3 29 Hillside Street,
Edinburgh,
EH7 5HD

Single Survey

Survey Report on:

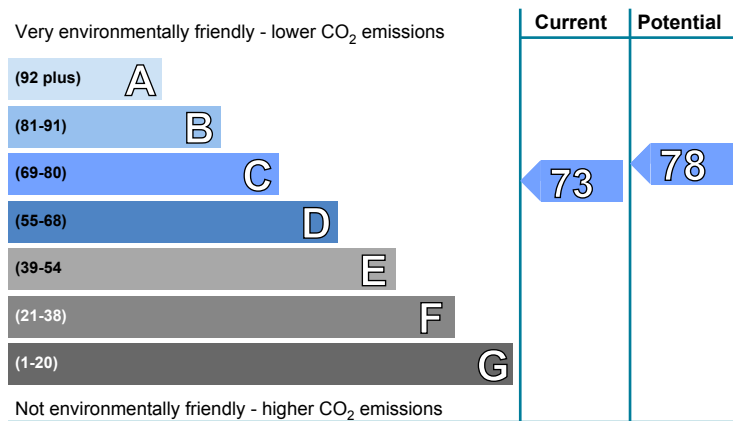
Environmental Impact (CO₂) Rating

This graph shows the effect of your home on the environment in terms of carbon dioxide (CO₂) emissions. The higher the rating, the less impact it has on the environment.
