# espc::home report

5/4 Clarice McNab Lane  
Edinburgh  
EH6 5FA  
25/06/2026

# Single Survey

<b>Property Address</b>	Flat 4, 5, Clarice McNab Lane, Edinburgh, EH6 5FA
<b>Reference</b>	1638721
<b>Customer Name</b>	Dr R Wescott
<b>Date of Inspection</b>	24th June 2026
<b>Surveyor's name, qualifications and office</b>	Charlie Barrett BSc (HONS) MRICS DM Hall LLP Chartered Surveyors 17 Corstorphine Road Edinburgh EH12 6DD  tel: 0131 624 6600  email: edinburghresidential@dmhall.co.uk
<b>Prepared By</b>	DM Hall LLP

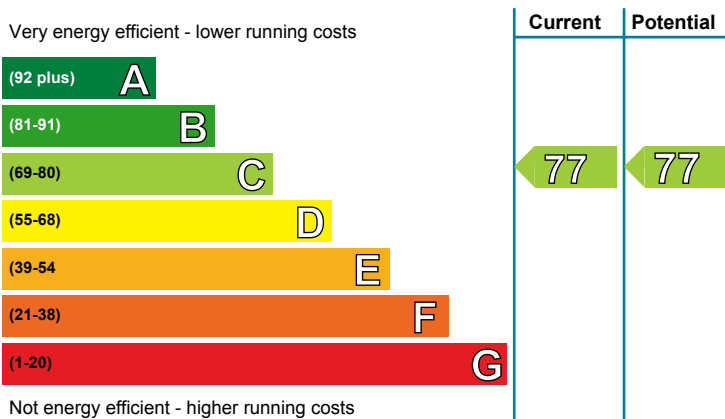
## Energy Efficiency Rating

This graph shows the current efficiency of your home, taking into account both energy efficiency and fuel costs. The higher this rating, the lower your fuel bills are likely to be.

Your current rating is **band C (77)**. The average rating for EPCs in Scotland is **band D (61)**.

The potential rating shows the effect of undertaking all of the improvement measures listed within your recommendations report.

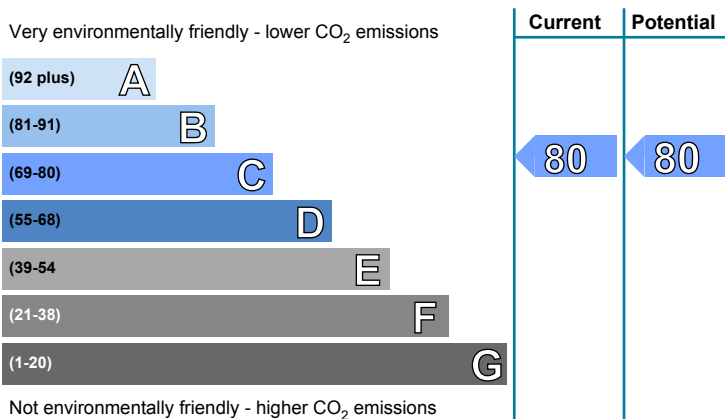
## Environmental Impact (CO<sub>2</sub>) Rating

This graph shows the effect of your home on the environment in terms of carbon dioxide (CO<sub>2</sub>) emissions. The higher the rating, the less impact it has on the environment.
