# espc::home report

97/4 East London Street  
Edinburgh  
EH7 4BF  
20/08/2026

97/4 East London Street,  
EDINBURGH,  
EH7 4BF

# Single Survey

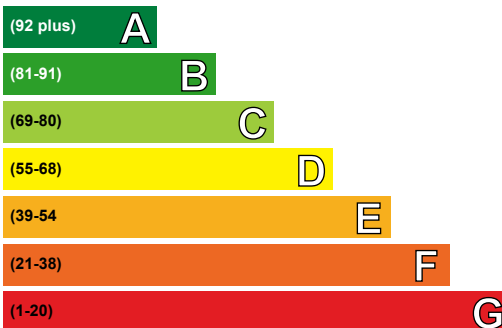
\* based upon the cost of energy for heating, hot water, lighting and ventilation, calculated using standard assumptions

Very energy efficient - lower running costs

Not energy efficient - higher running costs

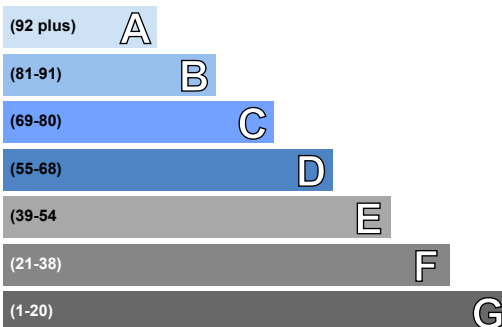
The potential rating shows the effect of undertaking all of the improvement measures listed within your recommendations report.

Very environmentally friendly - lower CO<sub>2</sub> emissions

Not environmentally friendly - higher CO<sub>2</sub> emissions
